RECONNAISSANCE REPORT ON GEOTECHNICAL AND GEOLOGICAL ASPECTS OF THE 14-16 APRIL 2016 KUMAMOTO EARTHQUAKES, JAPAN

Gabriele Chiaro¹, Gavin Alexander², Pathmanathan Brabhaharan³, Christopher Massey⁴, Junichi Koseki⁵, Suguru Yamada⁶ and Yudai Aoyagi⁷

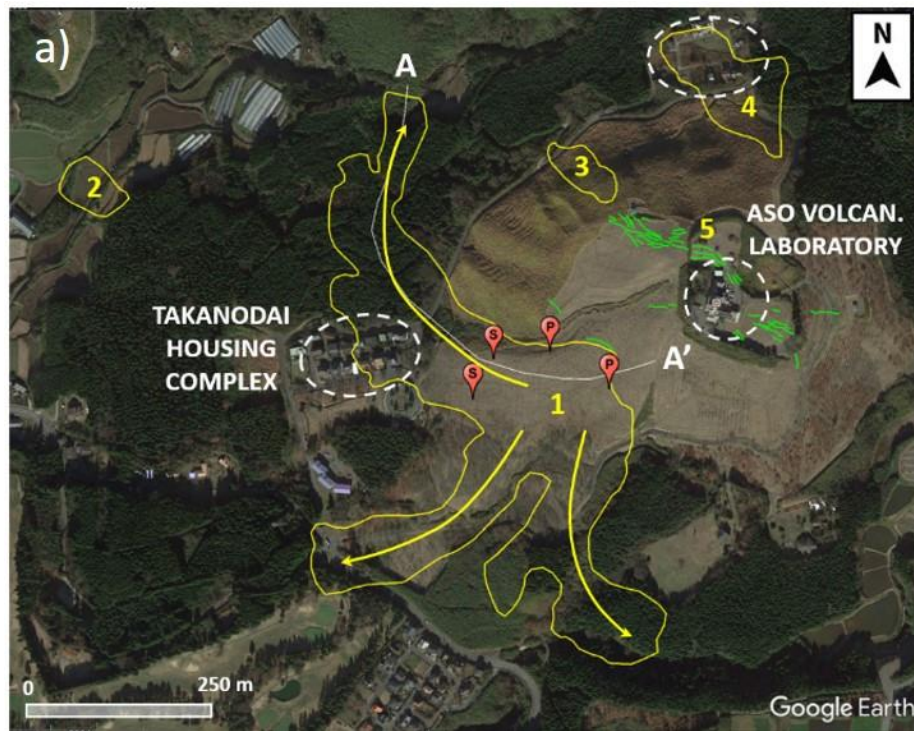
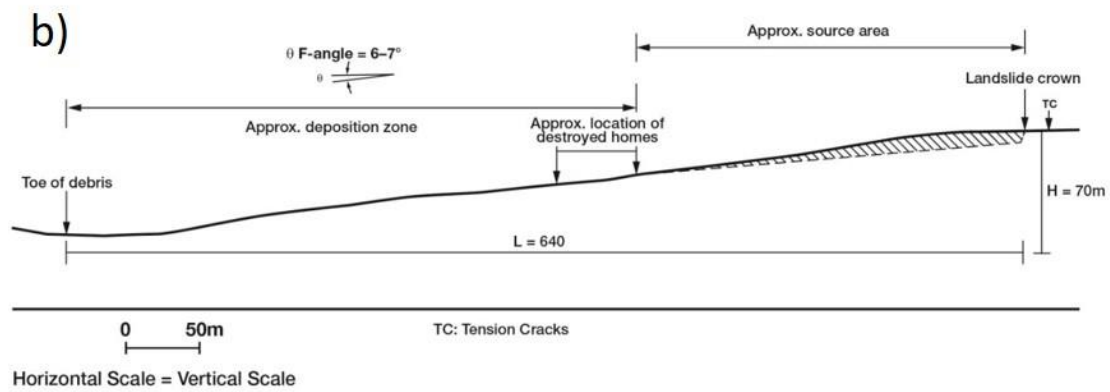
As shown in Photo 8, the slide surface was identified and traces of orange-coloured pumice soil were clearly noted on it. Two small trial pits (Figure 8) were excavated across the assumed slide surface and soil profile details are provided henceforward.

Figure 8: a) Google Earth image of the earth flow/slide near the Aso Volcanological Laboratory near Kurokawa. Location 9 in Figure 2 (No.1: main landslide; No.2-4 minor earth slides; No. 5 cracks; A-A' cross-section; s: soil sampling; p: trial pits); and b) cross-section through the Takanodai earth flow/slide.

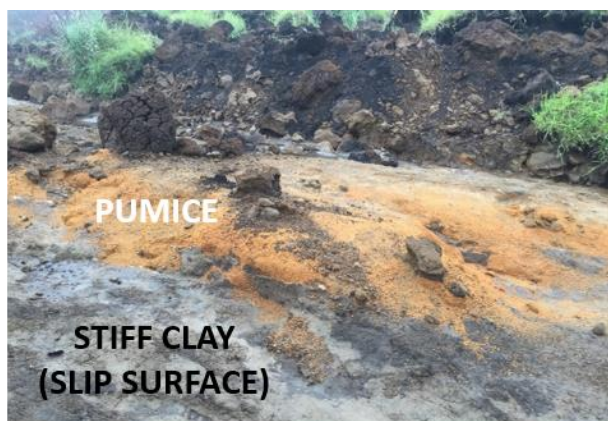
Photo 8. Traces of pumice soil on the slide surface

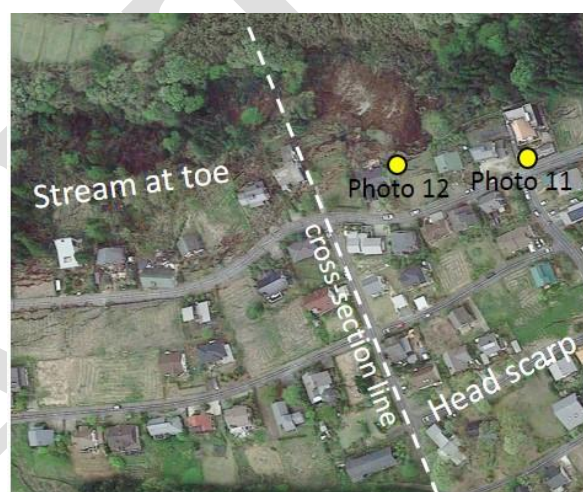
Intact displaced rafts of debris on a low angle slope (about 3°) appeared to be translating along rock head. A graben had developed at the head scarp, with slumping (rotation) and toppling of the debris rafts adjacent to the steeper slopes of the stream, near the toe of movement (Figure 12). Cumulative lateral displacements were greater than 2.5 m horizontally, localised vertical displacement of up to 1 m were recorded across some cracks. There is a possibility of on-going displacement due to water ingress through cracks and broken services. Volcanic soil and subdivision fill overlay the rock.

Figure 11. Google Earth image of the earth slide/slump at Tokyu Country Town (Location 12 in Figure 2). This landslide damaged about 40 homes.

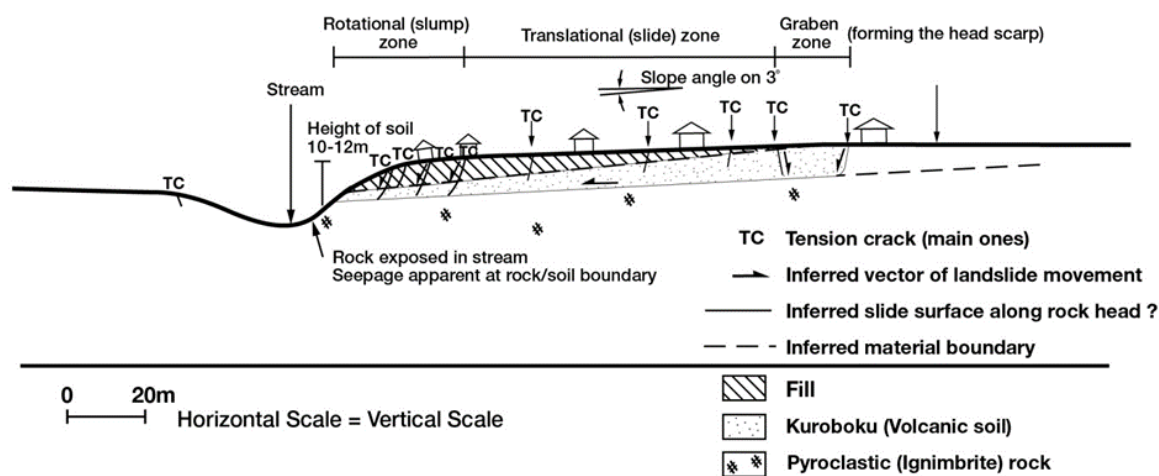
Figure 12. Cross-section through the earth slide/slump at Tokyu Country Town.

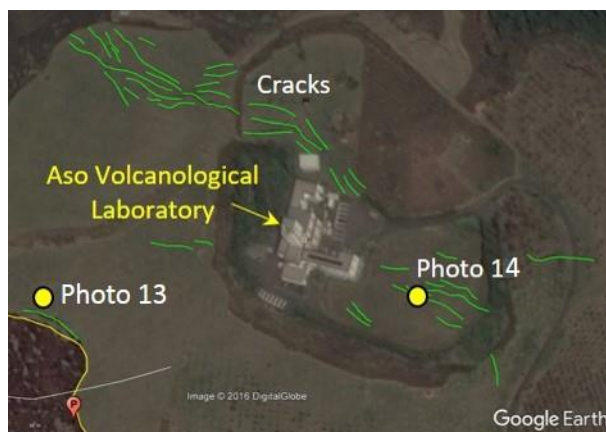
The Aso Volcanological Laboratory appeared to be damaged and had been red placarded. Services and other infrastructure crossing the cracks are likely to be severely disrupted. There is potential for future landslides to occur from water ingress, which could impact on homes below not already damaged.

Figure 13. Google Earth image of the incipient landsliding at the Aso Volcanological Laboratory. Location 8 in Figure 2.

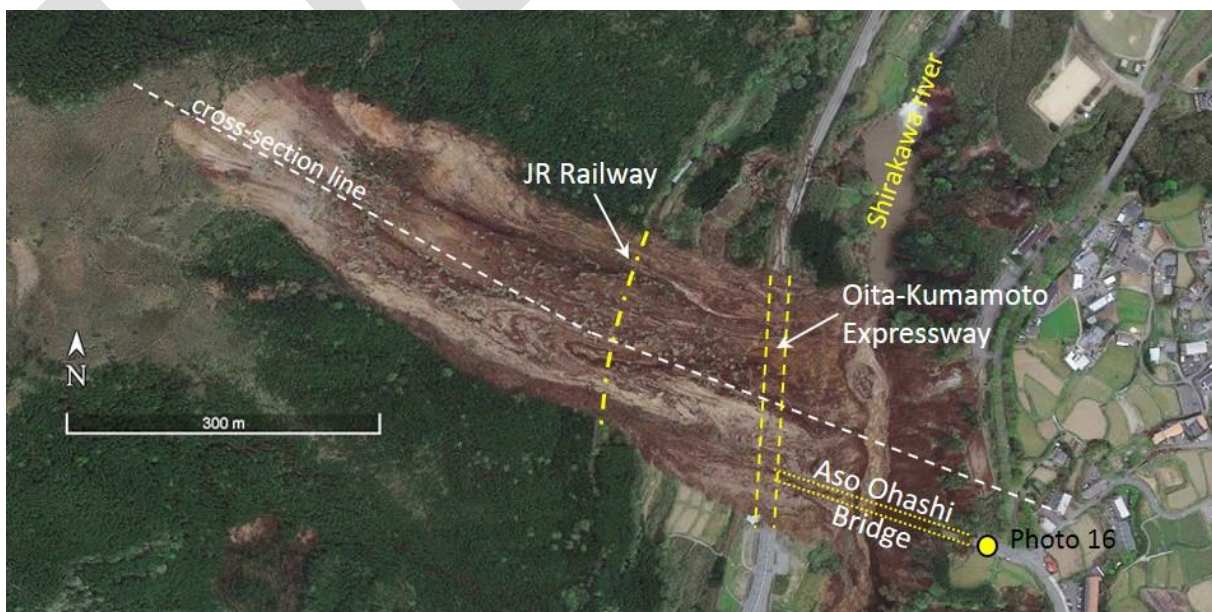
Figure 14. Google Earth image of the debris avalanche that destroyed the main road bridge across the Shirakawa River (Location 10 in Figure 2).

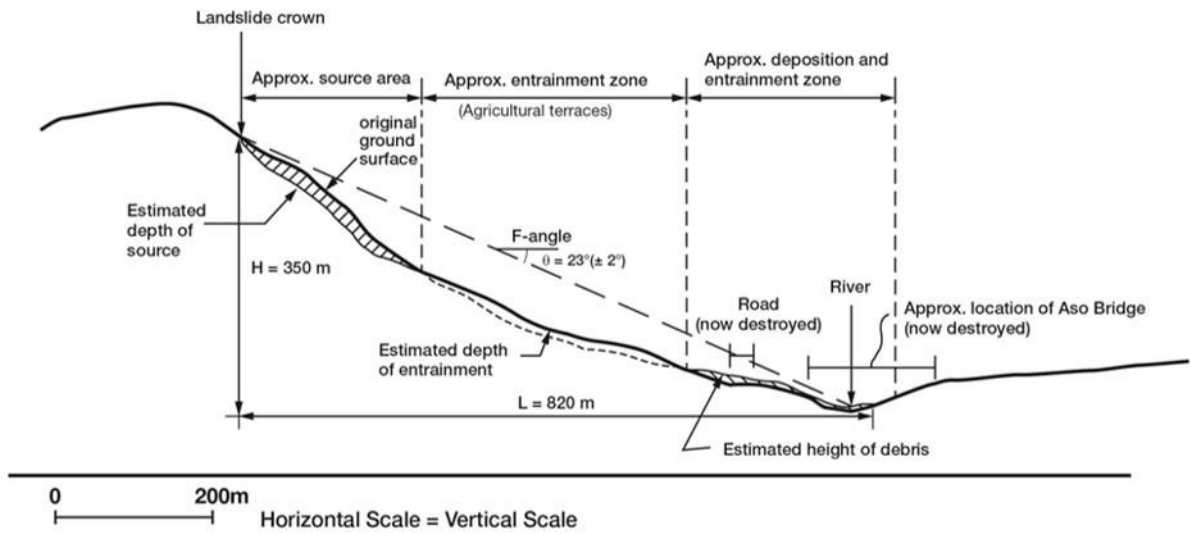
Figure 15. Cross-section through the debris avalanche that destroyed the Aso Ohashi Bridge.

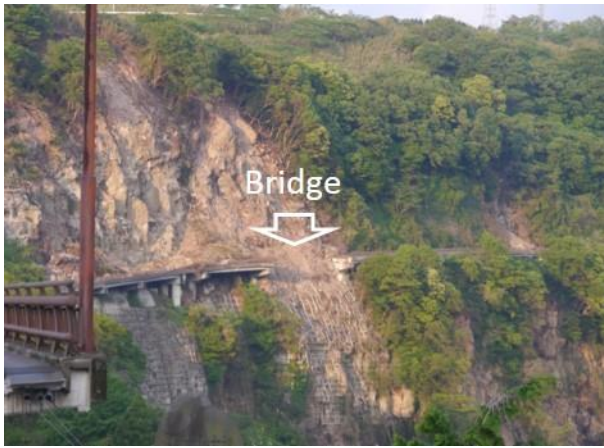
Roads, power lines and other services were severely damaged by lateral displacements in the areas of cracking. A bridge deck (an alternative route across the Shirakawa River) was completely destroyed by one debris avalanche (Photo 17). Moreover, the western abutment of another bridge across the river (which was still intact) dropped by about 1.5 m vertically, making the bridge deck inaccessible to vehicles (Photo 18). The damage to these bridges and the Aso Ohashi Bridge mean that the main access route to Kumamoto City is now via an alternative route that winds up the slopes of the caldera, adding approximately two hours of journey time to Kumamoto City.

Photo 17: Bridge deck destroyed by a relatively small debris avalanche (N 32.8752; E 131.9886).

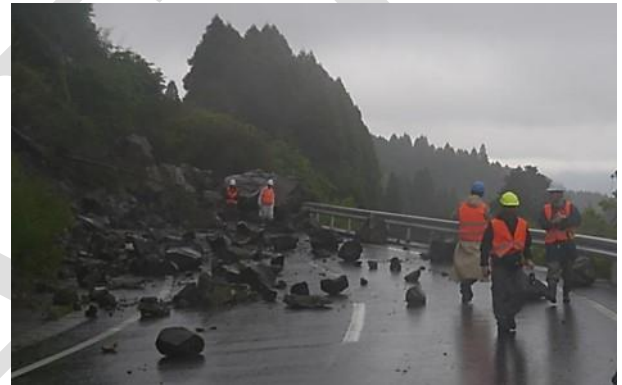
Photo 19: Typical rock fall on the road near the Tochinokibaru hot spring (N 32.8746; E 131.9884)

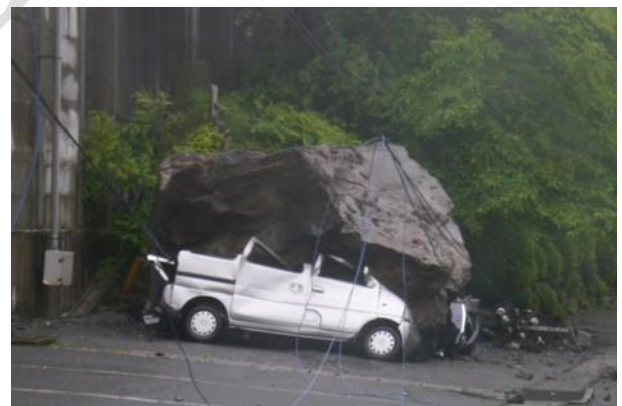
Photo 20: Cars crushed by rock fall near the Tochinokibaru hot spring (N 32.8711; E 131.9982)

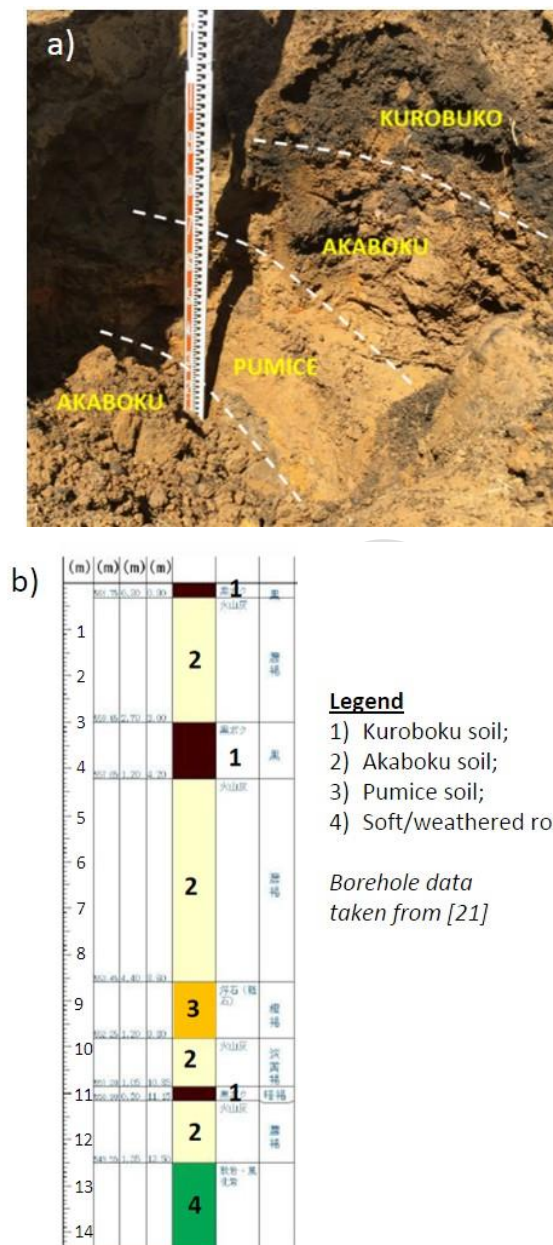
Soil exposed in the trial pit and a borehole describing a typical soil profile up to the depth of 14 m is reported in Figure 17. The soil consists of (1) Kuroboku volcanic ash with organic contents (black colour); (2) volcanic ash Akaboku (red/brown colour); (3) pumice soil; and (4) soft/weathered rock. Significantly, water seepage was clearly observed within the pumice soil layer, indicating that the Akaboku ash soil (clay-like soil) is much less permeable than the pumice soil.

It is not known which material initiated the failure, but it is possible that the slide surface may have been: i) in a wet thin (>10 cm) halloysite pumice layer; ii) in an underlying thin (about 10 cm) very wet clay layer; or iii) at the boundary between the two. The NZSEE team took block samples of these materials for laboratory testing.

Figure 17: a) Soils exposed in wall of a trial pit excavated in the northern flank of the landslide; and b) typical borehole data around Aso Volcanological Laboratory [taken from 21]

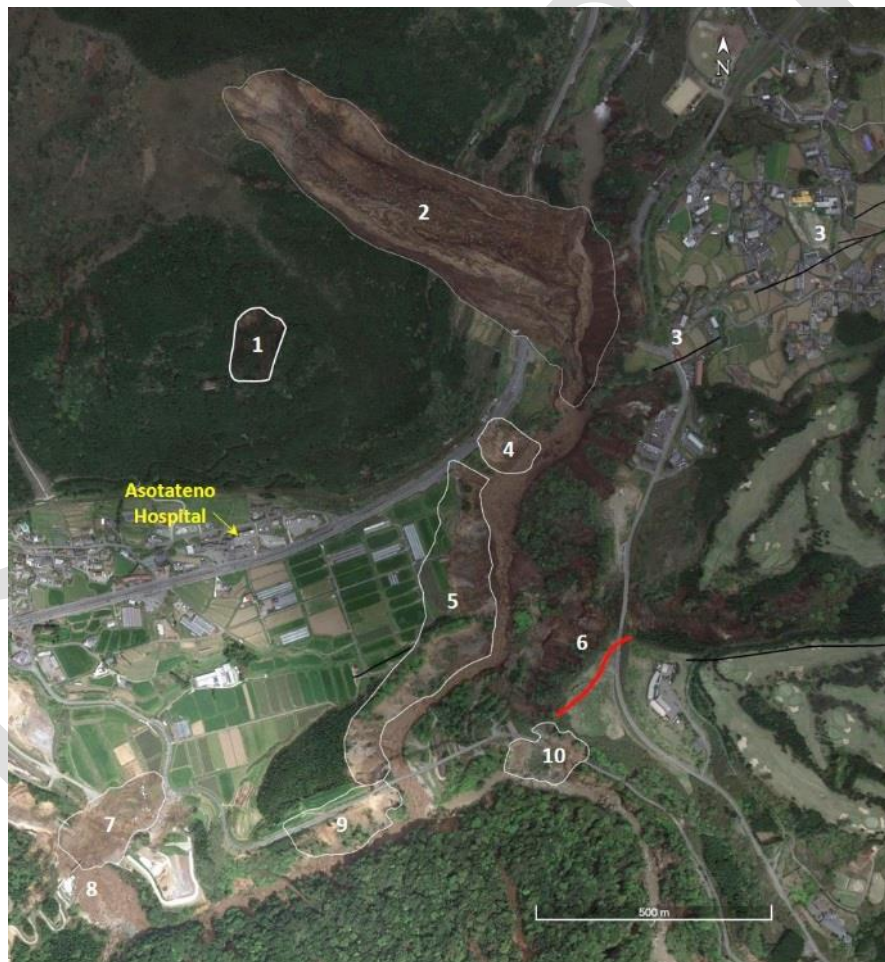
- 1: Debris flow threatening Asotateno Hospital
- 2: Debris avalanche destroyed highway and the Aso Ohashi Bridge (c.f. Photos 15 and 16)
- 3: Fault rupture severely damaged buildings (c.f. Photo 5)
- 4: Debris avalanche undercut highway making it impassable
- 5: Debris avalanche and cliff top recession and cracking destroyed the high voltage transmission line
- 6: Incipient landsliding severely impacts bridge making it impassable
- 7: Earth flow/slide destroyed railway line
- 8: Access to dam construction site destroyed
- 9: Incipient landsliding in rock and debris avalanches caused road bridge to settle (c.f. Photo 18)
- 10: Debris avalanche destroyed road bridge (c.f. Photo 17)

Figure 20: Location of critical infrastructure concentrated along the main Shirakawa River valley at the natural break in the slopes forming the outer crater. Multiple hazards occurred in this area as a result of the earthquakes, active faulting and landslides, and as a result the main bridges were destroyed and power transmission lines across the river required interim replacement.

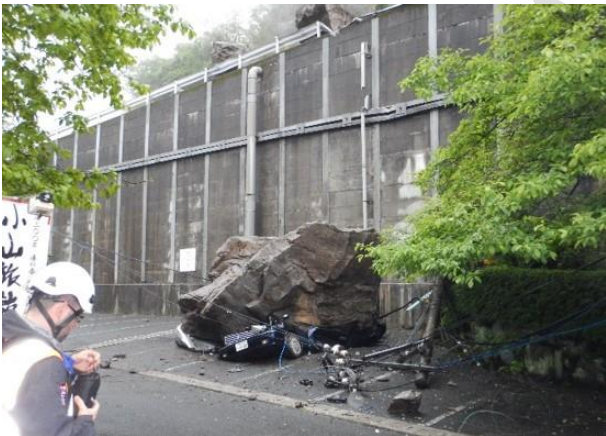
A tied-back wall (8 m high) with steel soldiers and a single row of small diameter anchors, apparently with expanded polystyrene (EPS) backfill, appeared to have performed well despite numerous boulders had landed on the road supported by it (Photos 31 and 32).

Photo 31: Good performance of a tied-back retaining wall with EPS backfill (N 32.8711; E 130.9916).

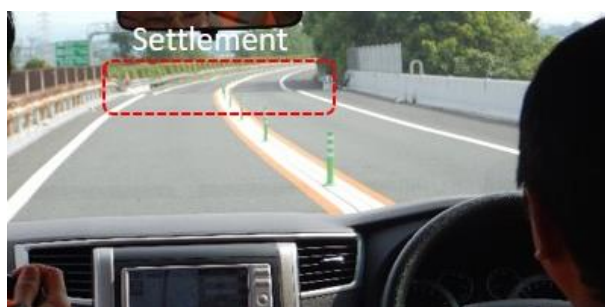
Expressway on embankment over low lying area suffered differential settlement which was particularly evident where the road passed over underpasses. Less settlement occurred at the structures than at the adjoining fill (Photo 49).

Photo 49: Settlement of expressway on embankment (N 32.7789, 130.7939).

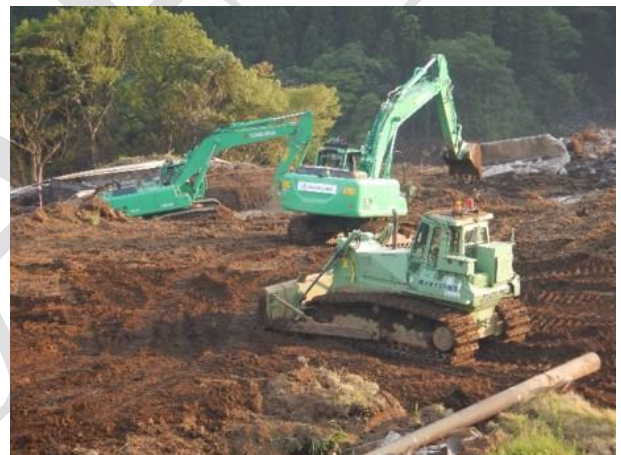
construction equipment and infrastructure. Such damage is due possibly to fault rupture (Photo 52). At the time of the survey, remotely-controlled machines were used to clear up the site and rescue buried construction equipment in safety (Photos 53).

Photo 53: Remotely-controlled machines used to rescue buried construction equipment (N 32.8776; E 130.9764).
